Manhole Inspection Summary

Manhole # S13II1002MH

Insp Date: **6/13/07 11:28 AM**

Location Address: **3141 OAKFORD AVE**

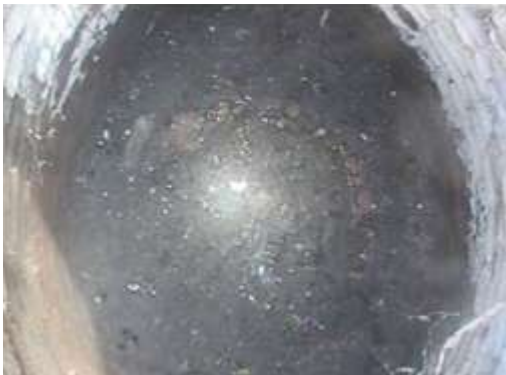
Defect 2

CHANNEL DEBRIS

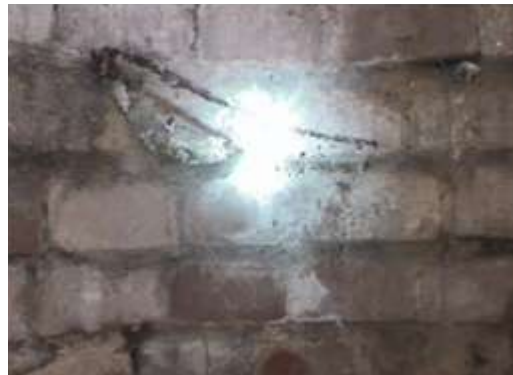
Defect 1

Count: **2** Missing: **2** ☒ **Corroded**

MISSING RUNG

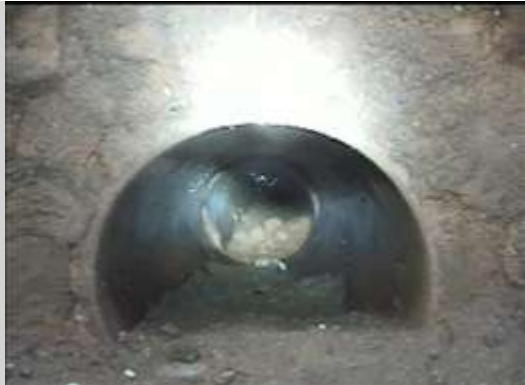
12 O'Clock Outflow

8 in. Circular Gravity Sewer
Pipe Out @ 12 O'Clock

Deposits: ☐ None ☐ Mud ☐ Sludge ☒ **Debris** ☐ Grease

Silt Depth: **1.5** (in.) Deposits Extent: **Medium**
